CHEMICAL & MECHANICAL CLEANING OF SPIRAL TUBE EXCHANGERS IN HYDROPROCESSING.

Presentation

Case Study

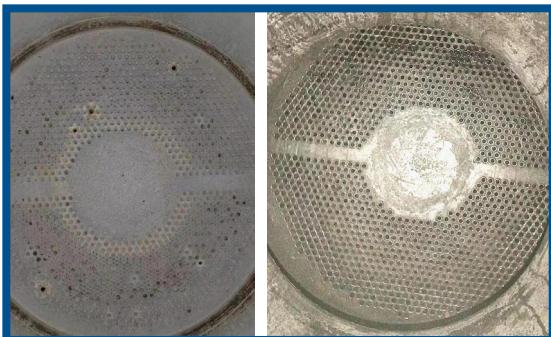
Figure 1 : Before and after cleaning pictures tube side

The following table presents the operational data recorded before and after the cleaning, while Figures 1 and 2 provide images of the tube side and shell side.

The cleaning process, which included mechanical and chemical cleaning of the tube side and chemical cleaning of the shell side, was completed in 16 days. Following the cleaning, both thermal and hydraulic performance were restored to levels close to those observed at the initial startup, despite 12 years of continuous operation. These performance levels have remained stable since the cleaning.
