CHEMICAL & MECHANICAL CLEANING OF SPIRAL TUBE EXCHANGERS IN REFORMING UNITS.

Case Study

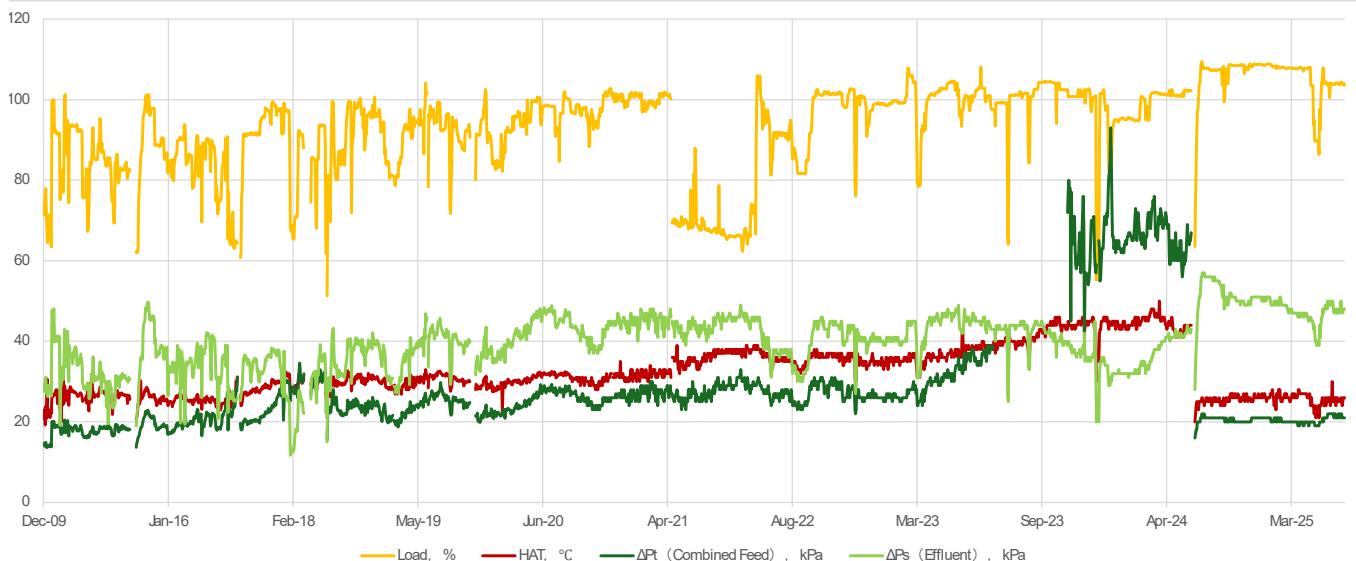
In October 2023, a rapid increase in tube side pressure drop up was detected, reaching almost 80 kPa. This issue was effectively managed through the injection of a fouling inhibitor, which stabilized the pressure drop at an average value of 60 to 70 kPa.

By June 2024, the decision was made to clean the exchanger to restore the thermal and hydraulic performances of the exchanger.

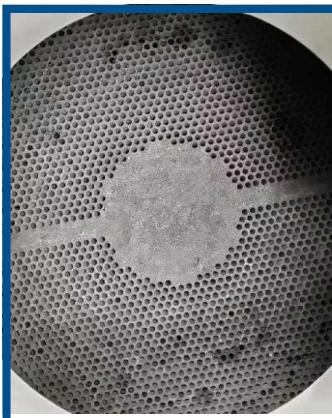
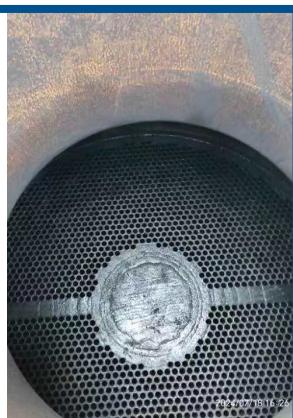
Before and after cleaning pictures tube side

During the unit shut down and maintenance, the cleaning was performed on the tube side (mechanical and chemical) and on the shell side (chemical). The entire operation was completed within 18 days.

The thermal and hydraulic performance was successfully restored at levels close to the initial startup, despite 15 years of continuous operations.

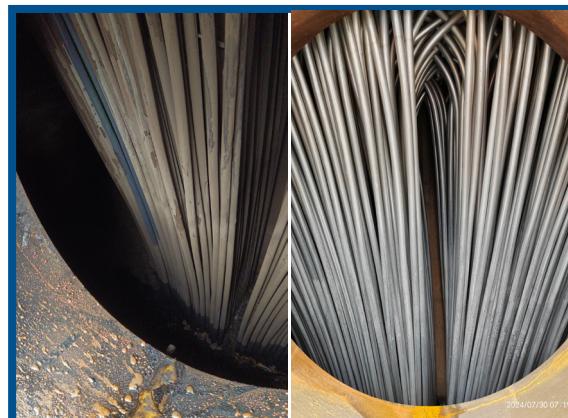
Before and after cleaning pictures shell side
